**Structures Design, Highway Services
Neighbourhoods and Climate Change**

Whorlton Bridge Update January 2021

Whorlton Suspension Bridge is a Georgian 55m (180ft) single span, wrought iron chain suspension bridge which spans the River Tees to the south of Whorlton Village, County Durham. The bridge is the UK's earliest surviving example of a wrought iron chain suspension bridge with twin battered masonry pylons to each end, designed by John and Benjamin Green and opened on the 7th July 1831.

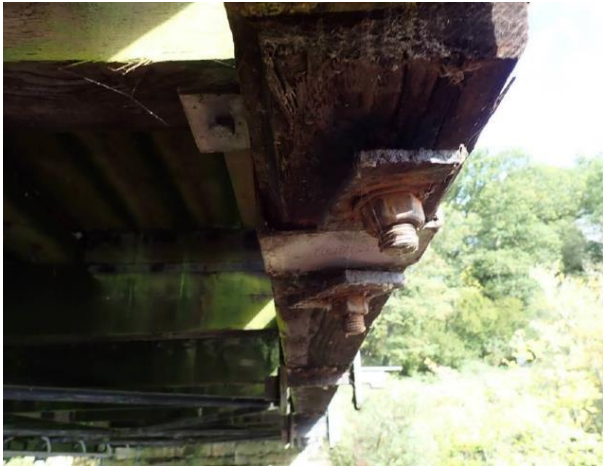
Loss of section was noted to the main longitudinal timber at the interface with the abutments. Multiple loose bolts were noted to the longitudinal timber scarf joints together with minor displacement of the joints. Facia boards were found to be loose, with one board missing on the west elevation.

Image 1 - Typical condition of longitudinal timber and loose bolts

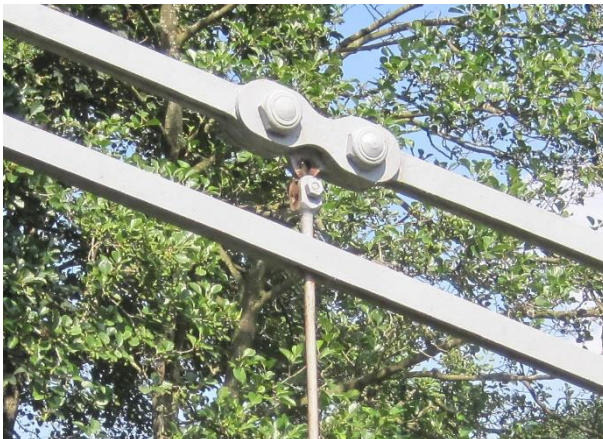
Hanger number 34 on the west chain has failed where the hanger connects to the chain. This defect does not appear to be unique with elongation or pin wear occurring at many other hanger/chain connections across the bridge.

Image 2 - Broken hanger to west elevation

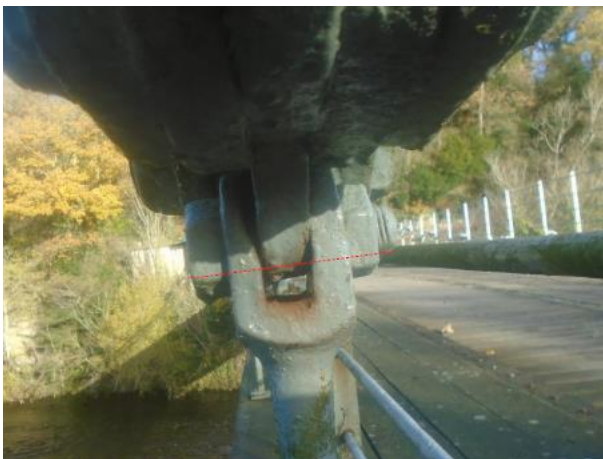
Image 3 - Typical indication of wear to other hanger/chain connections

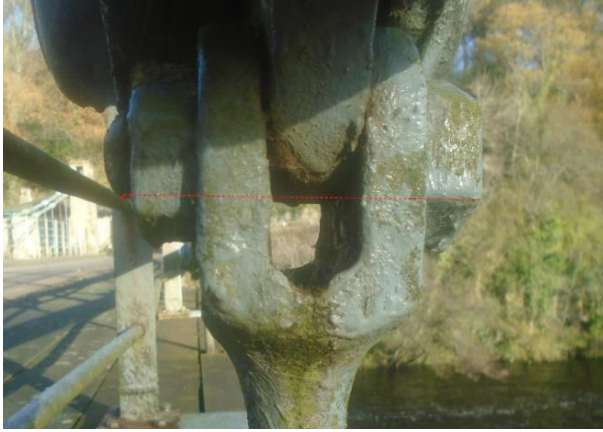
Image 4 – Typical indication of wear to other hanger/chain connections

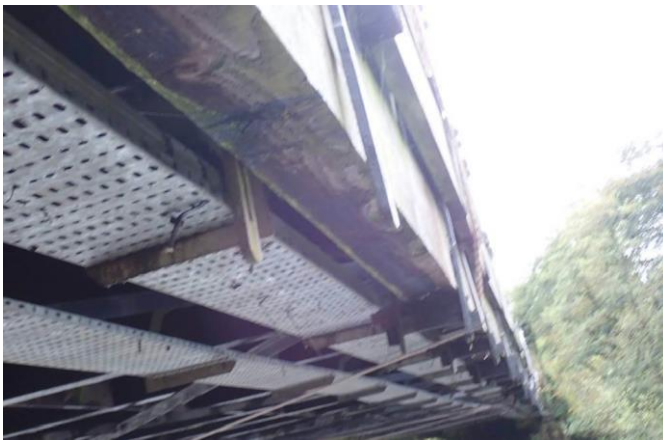
Other defects noted included deformation of hangers and missing wedges used to secure the longitudinal beams to the hangers.

Image 5 - Missing securing wedges

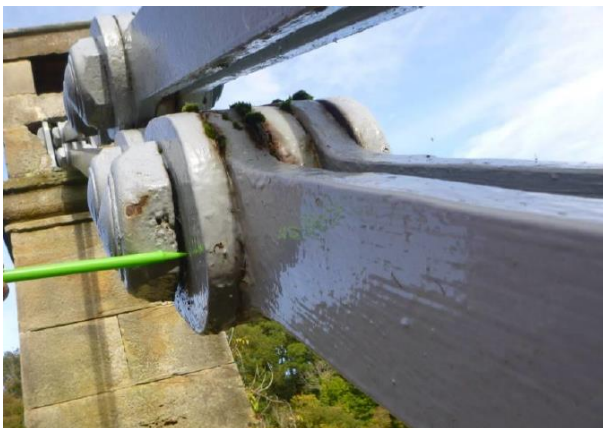
Generally, the chains were found to be in fair condition with sporadic corrosion noted throughout, predominantly to the chain pin connections. Contact between the chain and the tower coping was noted to all four towers on the anchor side of the tower. There are higher levels of surface corrosion within the anchor chambers. Deformation to a link pin on the south east back stay was noted.

Image 6 - Deformation to chain link pin
