Conservation Area Appraisal

Burnopfield

December 2009

CONSERVATION AREA APPRAISAL BURNOPFIELD

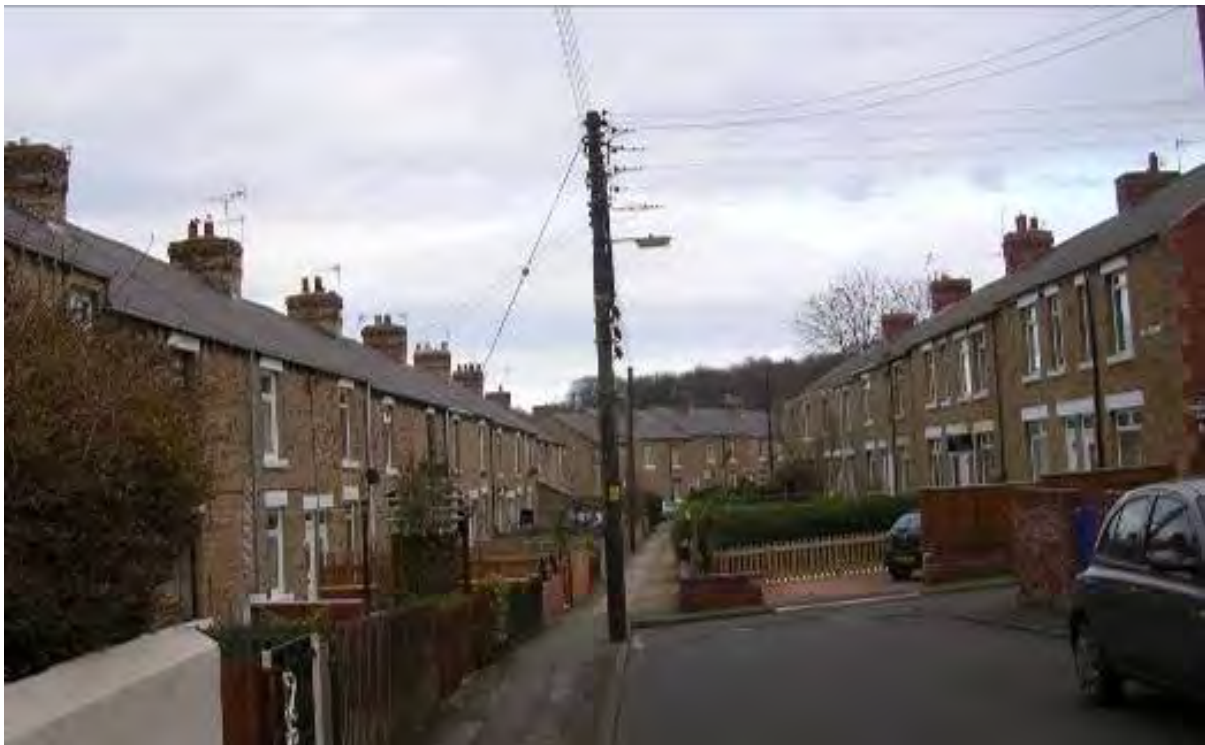
Park Terrace and Park View – turn of the 19th / 20th century stone terraces that contribute to the character of the core of Burnopfield

Park Terrace and Park View are made up of terraces of stone properties with slate roofs and distinctive regularly spaced projecting chimney stacks. Park View is a single terrace, and Park Terrace is made up of two terraces of properties that face one another, with small front garden areas and a central path.

Park View dates from the late 19th century and is contemporary with the eastern properties of Derwent Terrace. Park Terrace dates from the turn of the 19th / 20th century and is contemporary to Dene View. Park View and Park Terrace are less grand in design than those of Derwent Terrace and Dene View and were constructed as lower status houses, but they form part of the same phase of development and use the traditional building materials of the area. They largely retain their historic integrity, maintaining original openings and a distinctive roofscape. To the south, Park Terrace and Park View are surrounded by brick terraces, also dating from the turn of the 19th / 20th century, and early – mid 20th century semi-detached properties. The different use of materials offers a clear change in character, and a logical boundary for the conservation area.

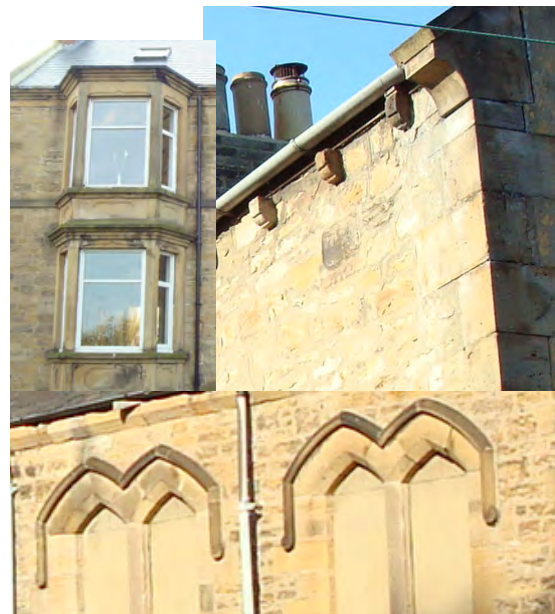
Stone is used for the adornment of properties within Burnopfield conservation area

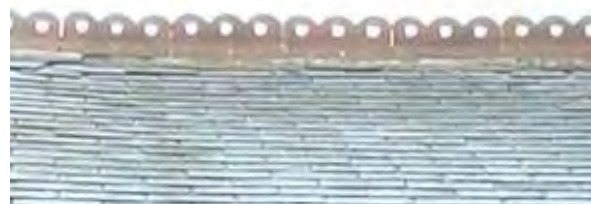
Slate creates the distinctive roofscape of the conservation area. In some instances, terracotta ridge tiles were used to add interest

Slate creates the distinctive homogenous roofscape of Burnopfield. Typically Welsh slate was used, laid in even courses. Most of this traditional roofscape has survived and is an important feature of the village. Some properties have stone coping to the gable ends and others have terracotta ridge tiles that add interest. Historic photographs show that pantiles were historically used for roofing in the village, but they no longer form part of its character.

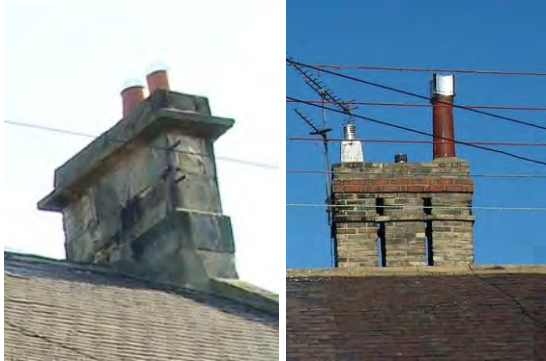
Chimney stacks constructed of stone, red or buff brick are an integral part of the design of buildings

Chimney stacks project from the ridgelines, these are constructed of either stone, red brick or buff brick and can be quite ornate and an integral part of the design of the building to which they belong. The use of a combination of buff and red brick to create designed stacks is a characteristic of some properties of the area. Terracotta pots, where they are in existence complement the chimney stacks.

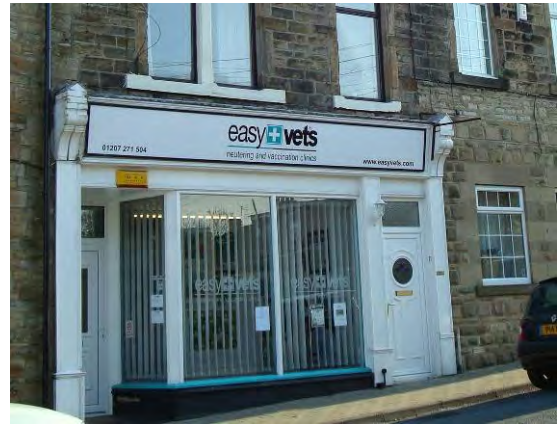
Busty Bank – Many of the details of this traditional shopfront have survived

Timber was traditionally used for windows, doors and shopfronts. Over time, many have been replaced with modern designs and materials, which have served to undermine the character of the area. However, some examples of traditional joinery have survived and where this is the case they contribute greatly to the character of the building and the area.

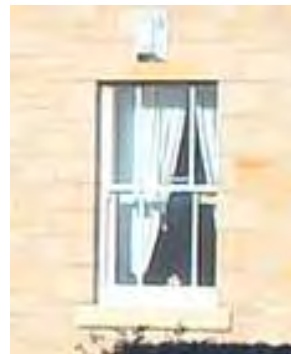
Where traditional sash windows are found they form an integral part of the character of the building and the area

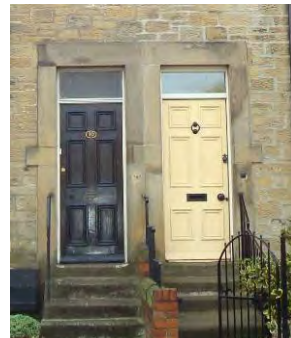
Dene View – Some traditional timber panelled doors have survived and others have been replaced. Where traditional details have survived they contribute greatly to the character of the terrace.

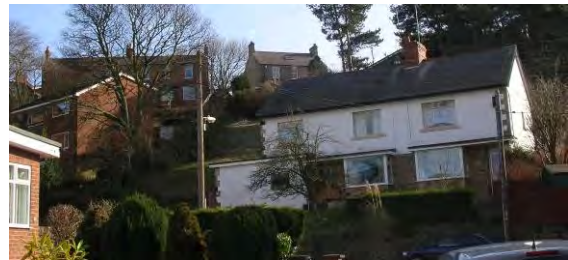
View up Sheephill from Busty Bank – development responds to the gradient of the land stepping up the hillside

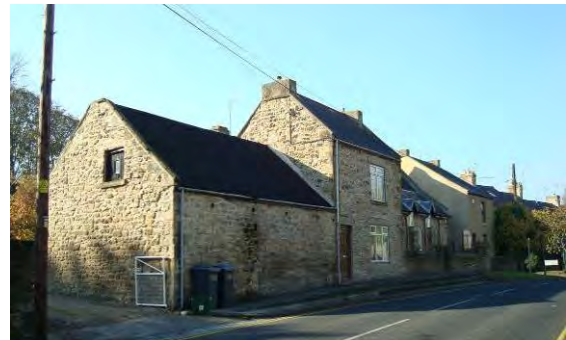
6 Front Street – an example of a simple vernacular structure that characterise this part of Burnopfield

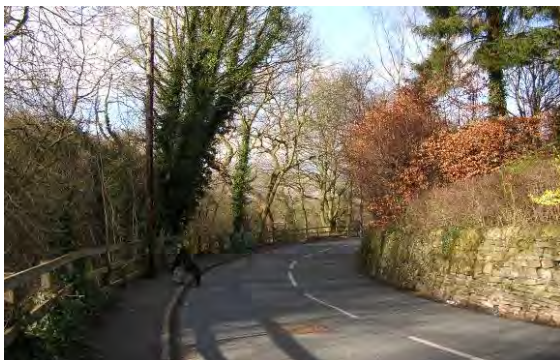
Busty Bank – drystone walls are a key feature of this area

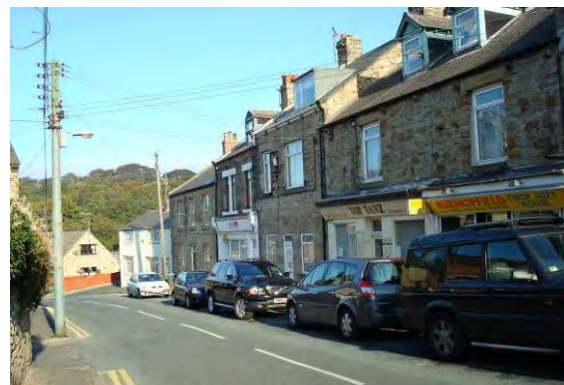
Busty Bank – the commercial core of the village. Terraced properties of varying design step down the hill

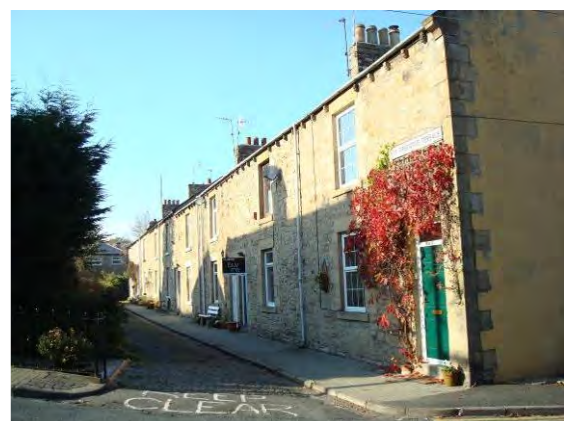
Co-operative Terrace – typical of the terraces that stand perpendicular to the commercial Busty Bank

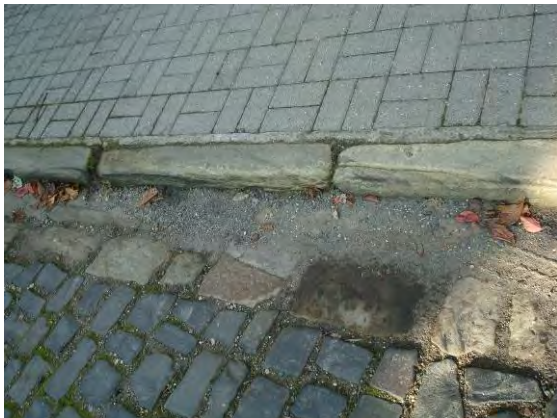
Granite setts and stone kerbs on Co-operative Terrace

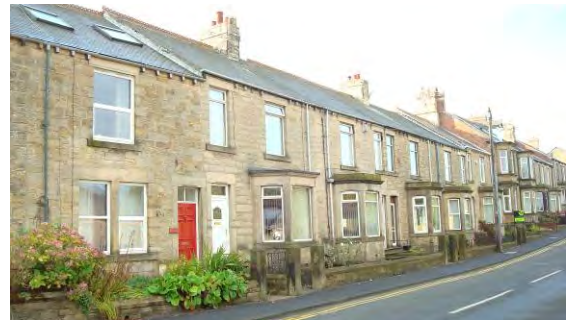
Dene View, Front Street – the regular pattern of distinguished turn of the 19th / 20th century terraces characterise the area

Distinguished turn of the 19th / 20th century stone terraced houses dominate Front Street. Derwent View and Dene View, with their regular pattern of bay windows, gatepiers and projecting chimney stacks, draw the eye through the centre of the conservation area. Further to the east, Grove Terrace and Oaks Terrace continue this pattern of development. Park View and Park Terrace, to the south of Front Street, are contemporary to Derwent View and Dene View and of stone construction,

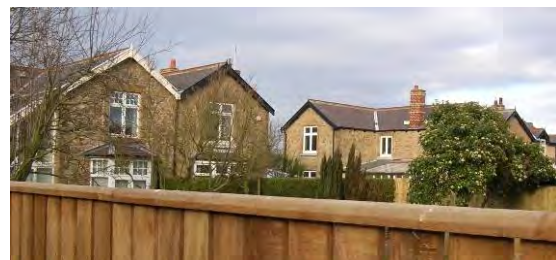
Leazes Villas – early 20th century large semi-detached properties. Continuing the grand tradition of Front Street and illustrating the evolution in design styles

Buildings tend to be set slightly back from Front Street and have small front garden areas, complementing the slightly grander style of architecture in this character area. The only deviations from this are the fold pattern of development around Sandypath, and Leazes Villas, which are two rows of villas accessed from a central rear alley.

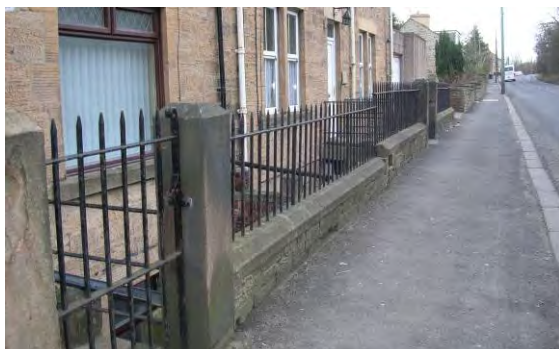
Grove Terrace – traditional railings on top of low boundary walls, typical of this character zone

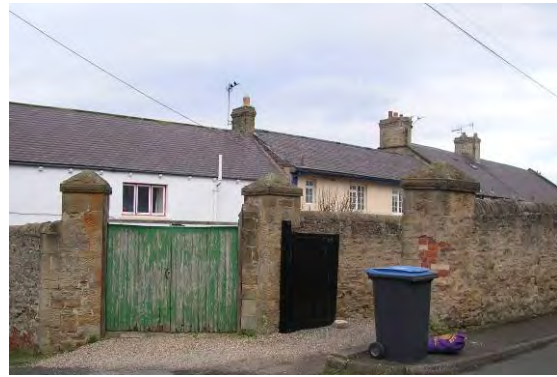
Rear boundary and gatepiers of 13 Front Street – interesting features of the area

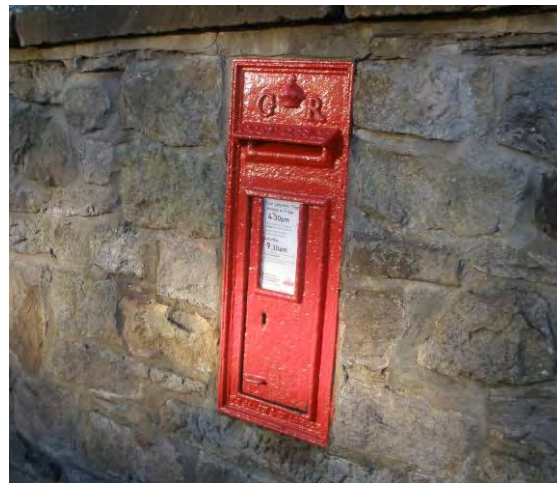
The postbox built into the wall of 30-32 Front Street, an asset to the streetscene

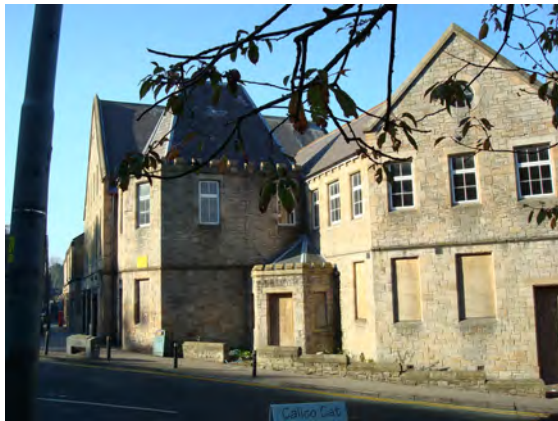
Redundancy is an issue that affects a small number of buildings of interest in Burnopfield conservation area. The effect of long term redundancy is neglect and deterioration. This creates an eyesore within the village and risks the loss of irreplaceable historic buildings. The co-operative building (which is currently being restored and developed) is currently boarded up and a prominent example of this issue.

The old Co-operative building is redundant in part. This is a landmark building of Burnopfield

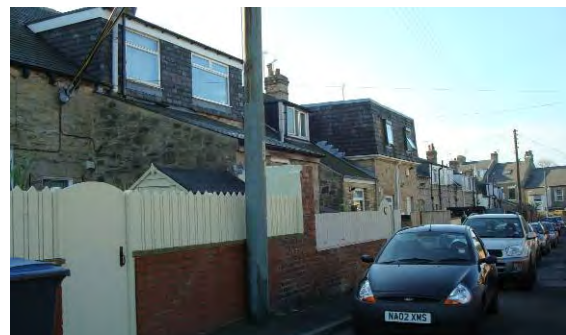
Properties in Burnopfield conservation area have undergone quite extensive alterations, which have served to undermine their historic character. There is a need to ensure that historic features and materials of interest are protected. Alterations include:

The rear elevations of Chapel Avenue have a mismatch of extensions and alterations

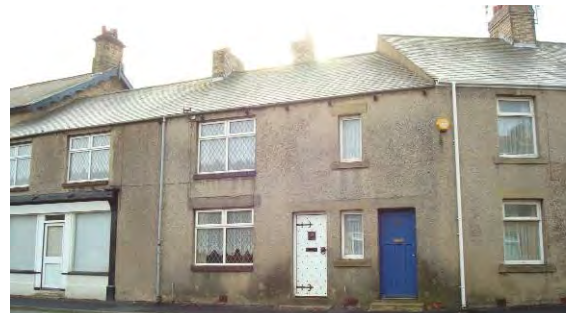
Some properties have been rendered, which serves to undermine the uniformity of the use of stone

The coherence of the conservation area has been undermined in some areas by the introduction of modern construction materials, such as render.

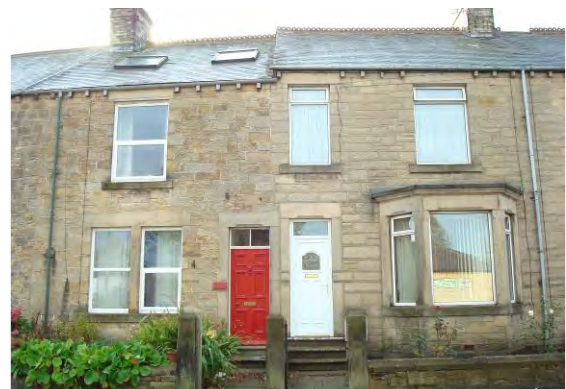
Many of the traditional door and window details have been lost. No. 4 has a traditional door, which is part of the design of the building and contributes to its interest

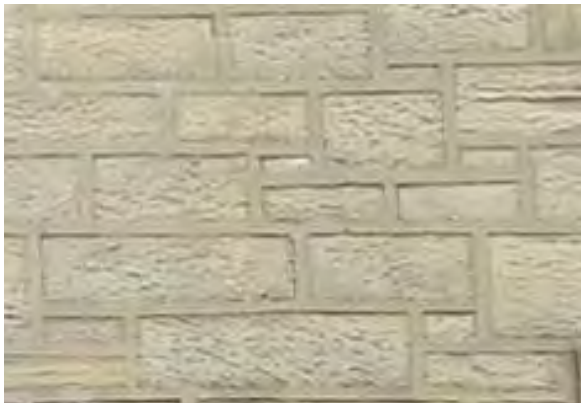
An example of inappropriate cement pointing that stands proud of the stone

The use of inappropriate materials or methods to repair traditional stone buildings can be harmful to the buildings, both to their appearance and potentially their structure. For example, the use of cement pointing and render can be particularly damaging, as it traps water into the stone and speeds erosion. Equally an incorrect finish on the pointing has a negative visual impact.

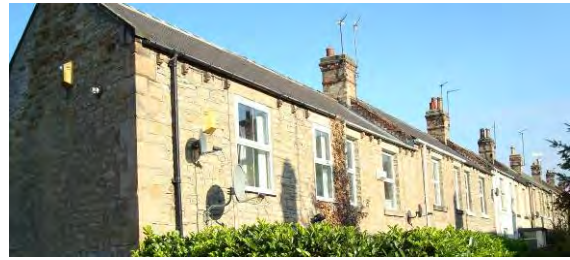
Modern paraphernalia, such as prominently located alarm boxes and satellite dishes, adversely affect the appearance of many elevations within Burnopfield.

Chapel Avenue – the front elevations are cluttered with alarm boxes and satellite dishes

- Repairs / replacement of barriers to woodland.
- Seek to reduce the amount of clutter on front elevations, by advertising the requirement for planning permission for satellite dishes and the potential use of enforcement powers.
- Seek to bring certain alterations under planning control by the use of an Article 4 direction: e.g. all boundary treatments and roof coverings.
- Work to improve boundary treatments within the conservation area – including the repair and reinstatement of stone walls and railings wherever possible.
- Environmental improvement scheme to improve signage and street furniture on Front Street and Busty Bank.
- Repair and maintenance of footpaths / roads/ bridleways.

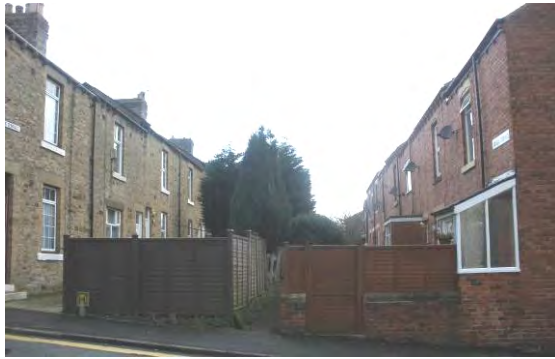
Throughout the conservation area, examples of inappropriate boundary treatments can be found. These can be inappropriate in terms of design, materials and height. The proliferation of fencing is a particular concern, especially when it is high fencing to front elevations. Also of concern is the mismatch of boundaries that is appearing in some areas.

Gibside Terrace – the high fence boundaries to front gardens of these properties makes the central path uninviting

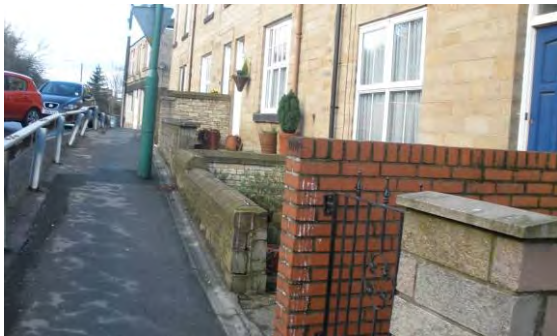
Oaks Terrace, Front Street – the mismatch of boundary treatments contrasts with the uniformity of the architecture

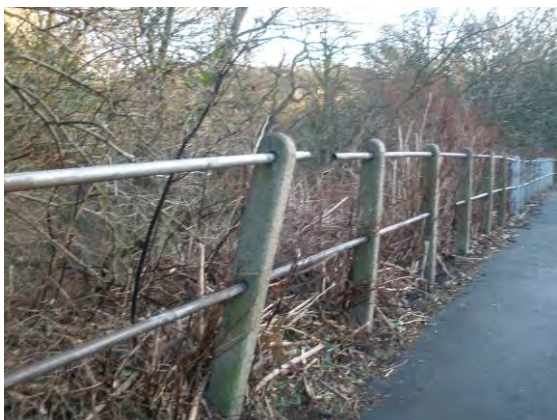
Barriers between the roads and woodland – some are in need of repair

- **Condition of barriers to woodland**
Concrete and steel barriers form the boundary between the roads through the area and the woodland. These are of no historic value and their design does not reflect the interest of the area. The condition of these is poor in some areas.

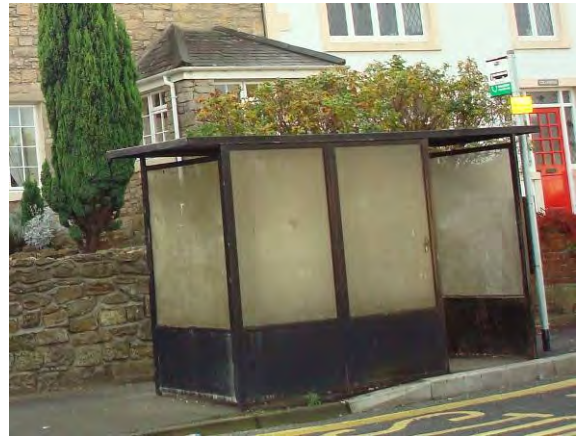
- **Street Clutter / Furniture**
Modern street signage and street furniture is a necessary part of modern life in the village. However, there is scope to better integrate this into the historic environment than is currently the case. A rationalisation of street signage would reduce disruption of the line of vision along the streets of the village. The design of street furniture could be better integrated into the streetscene to improve the appearance of the area.

Bus stop, Front Street – the design and location of this could be improved to enhance the appearance of the street.
